# **WATER MONITORING OF IKPOBA RIVER SOUTHERN NIGERIA**

**ETIOSA UYIGUE AND MATTHEW AGHO**

**COMMUNITY RESEARCH AND DEVELOPMENT CENTRE  
(CREDC), NIGERIA**

**IN PARTICIPATION IN THE 2006 WORLD WATER MONITORING DAY**

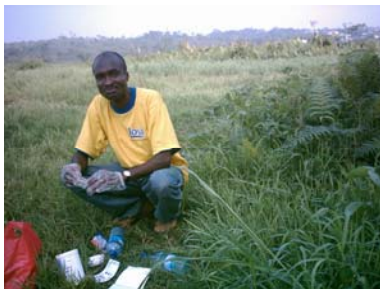
At site 1, the speed of the water was low. A large part of the width of the river was covered with grasses. This could be due to the high level of silt being deposited in this area because blockage caused by the presence of the dam. This result in decrease in depth as a result of silt deposition and the slow-flowing/absent of water current encourages the growth and proliferation of aquatic plants. This collaborated by the findings of Ogbeibu and

Oribhabor (2001). Also at this location, large amount of municipal waste is being deposited into the river from a drainage channel that runs along Okhoro Road. This explains the low pH of 6 recorded at this site. Decomposing organic mater reduces the pH aquatic systems, that is, they become acidic. The water temperature was higher at site one, which may be due to presence of the dam and the high deposit of municipal waste in this location.

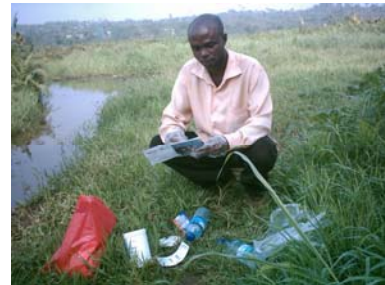
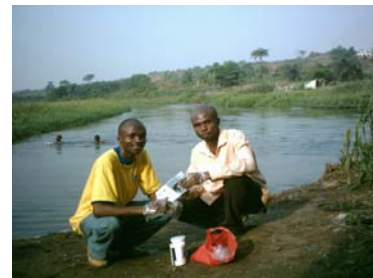
The river flowed faster in site 2 than site 1. Human activities in this location were higher. Car washing companies depending on the river and discharging their effluents into the river were present here. Also, a major abattoir is located nearby and those who patronize the abattoir wash their meat at this location. Children were also seen taken their bath and swimming at this point. Compared to location 1, the air and water temperature was

lower. But the pH recorded here was 7 suggesting that it was neither acidic nor basic.
